Investigation for Collapsed Navigation Structures in The Mahakam River Delta by Bathymetry and Sonar

This study employed an integrated approach of side-scan sonar imaging and bathymetric surveying to precisely locate and characterize collapsed navigation structures within the dynamic Mahakam River Delta. This crucial waterway faces environmental challenges like strong currents and heavy siltation, threatening navigational aid integrity. Accurate identification of these submerged hazards is vital for safe shipping and future infrastructure development. Our findings demonstrated the effectiveness of combining these hydrographic methods to accurately map the seafloor and detect anomalies indicative of collapsed structures. Visual diving confirmed extremely poor underwater visibility, necessitating remote sensing. High-resolution bathymetric surveys successfully identified distinct riverbed anomalies, notably a collapsed structure at 00°50'13.29" S / 117°18'24.51" E, exhibiting a 1-1.5 meter elevation change at 4.5 meters depth. Acoustic data supported its man-made origin. These critical findings directly informed recommendations for repositioning affected navigation aids to a safer l

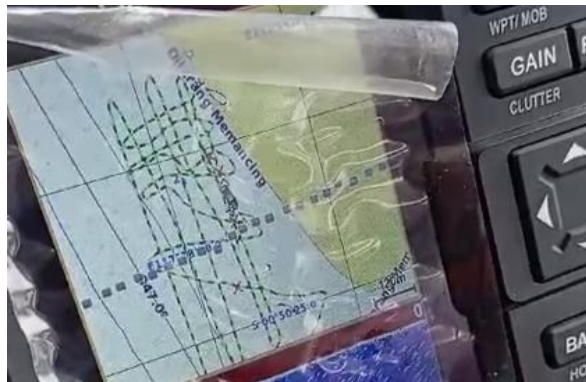
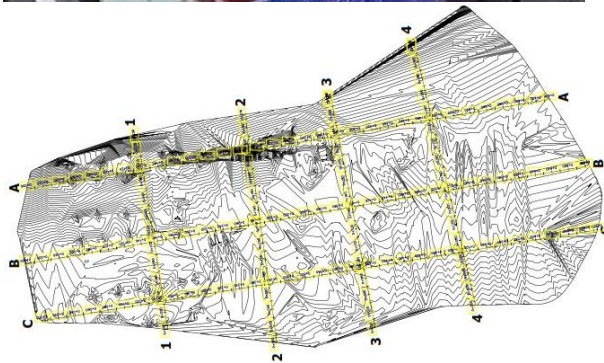
Figure 8. Identification Location

The integrated bathymetric and side-scan sonar survey successfully identified several submerged anomalies within the study area that are consistent with collapsed navigation structures. The bathymetric DTMs revealed localized depressions and irregular features on the seafloor that deviated from the natural riverbed topography. These features, often characterized by sharp edges and distinct profiles, indicated the presence of submerged objects. For instance, one significant anomaly (Figure 1a) showed a sudden depth change of approximately 3 meters over a small area, suggesting a prominent upright or partially collapsed structure.

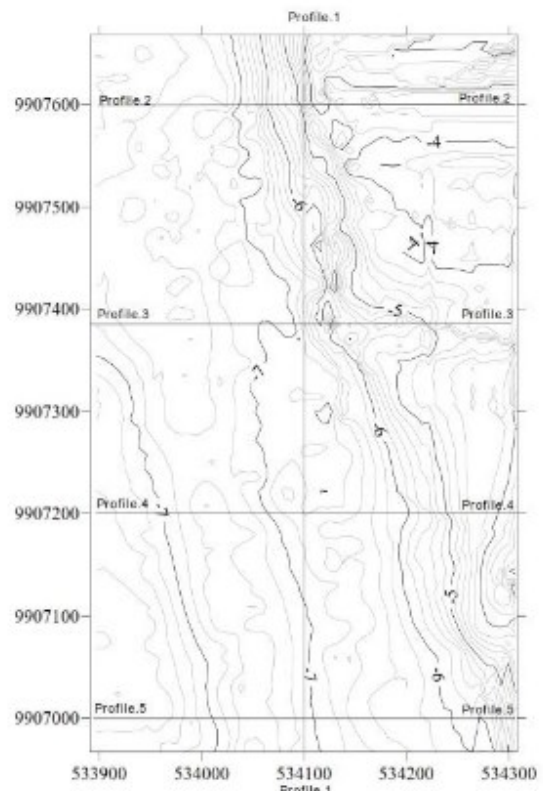
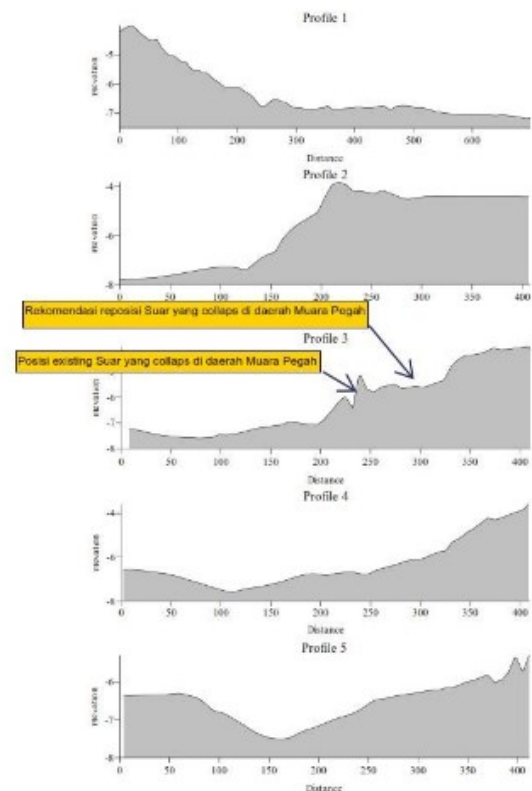
Figure 9. Building indications

Based on the provided bathymetric data, Figure 9, encompassing contour maps and cross-sectional profiles, provides a comprehensive view of the riverbed. Profile 3 clearly indicates a distinct anomaly labeled "Posisi exsisting Suar yang colaps di daerah Muara Pegah," confirming a collapsed beacon via an irregular depression. Complementary sonar imagery further supports this finding with acoustic returns at approximately 4.5 meters depth. The presence of this identified collapsed beacon at Muara Pegah poses a significant navigational hazard. Consequently, the survey not only pinpoints its exact location but also provides a "Rekomendasi relokasi Suar yang colaps," suggesting a safer alternative site on Profile 3. This holistic approach, from detection to relocation recommendation, is crucial for enhancing maritime safety and optimizing infrastructure in the Mahakam River Delta.

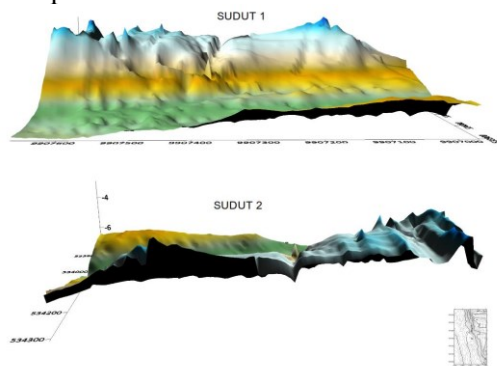
Figure 10. 3D view of Sonar results

The side-scan sonar mosaics provided detailed acoustic imagery of these anomalies. Objects appeared as bright returns with distinct acoustic shadows, clearly distinguishing them from the surrounding sediment. Figure 1b, corresponding to the bathymetric anomaly, clearly depicts a rectangular shape with a prominent shadow, consistent with a collapsed beacon or a large part of a navigation structure. The resolution of the side-scan sonar allowed for the identification of potential structural components.

Detailed 3D bathymetric models (Figures SUDUT 1 & 2) reveal a significant, 1-1.5m high elevation anomaly at 4.5m depth, precisely located at 00°50'16.8" S / 117°18'24.3" E. This distinct feature strongly indicates a collapsed structure on the riverbed. While side-scan sonar imagery (complementary to this data) would confirm its exact morphology, the identified obstruction necessitates a relocation recommendation for the associated navigation aid to ensure maritime safety and prevent hazards in the Mahakam River Delta.

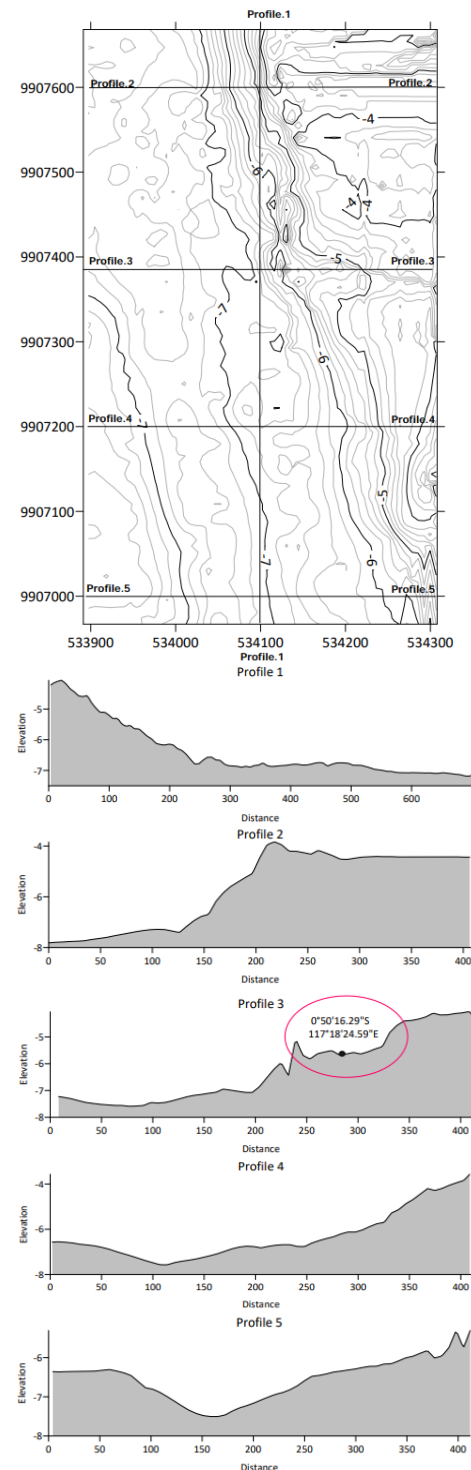
Bathymetric maps and profiles revealed a significant submerged anomaly, indicating a collapsed structure (e.g., beacon) at 0°50'13.29" S / 117°18'24.51" E. Side-scan sonar would confirm its precise nature. This structure poses a serious navigational hazard. Consequently, beacon repositioning to a safer location (0°50'16.29" S / 117°18'24.59" E) is

Figure 11. Recommendation for rebuilding position of navigation safety structure

recommended. The integrated use of bathymetry and side-scan sonar is crucial for effective hazard identification and infrastructure planning in dynamic waterways like the Mahakam River Delta.
