## Investigation of the Collapsed Dolphin Structure of the Mahakam Bridge Using Bathymetry and Side-Scan Sonar After Collision

Aco Wahyudi Efendi <sup>1\*</sup>

### **ABSTRACT**

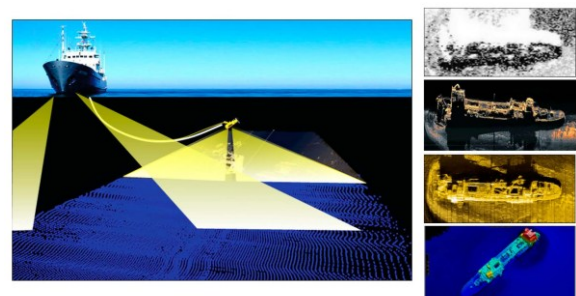
Figure 5. Results of the side sonar survey

- High-Backscatter Objects: Cylindrical and linear debris with acoustic shadows (Figure 5a), confirming man-made materials (steel/concrete) (Goncharov & Goncharova, 2023).
- Debris Orientation: Fragmented piles aligned parallel to currents, indicating post-collapse displacement (McLarty et al., 2020).

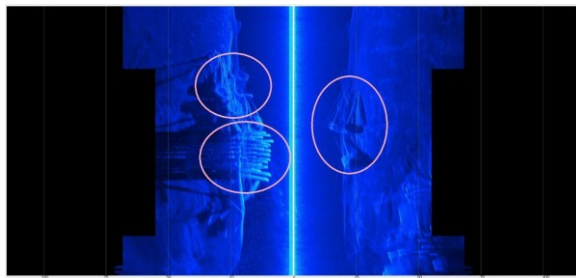
Figure 10. Sonar Image of Object Appearance

Based on figure 8 results, the condition of the riverbed reveals several identifiable objects within the Scan Window.

1. Bridge Piers

An object is interpreted as a bridge pier due to its characteristic round and long shape. The acoustic shadows visible behind the structure indicate that these objects have significant vertical dimensions, suggesting they extend high toward the water surface.

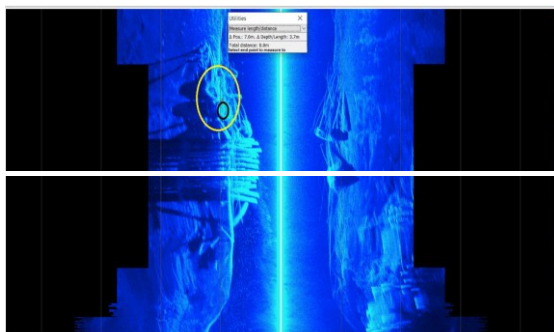
Figure 11. Dolphin Debris Object Dimensions

2. Fender Debris

An object is interpreted as fender debris due to its circular shape. This particular circular section is similar in form to the original bridge fender. The visible dimensions of the fender debris object, as outlined in the black circle (in the image results), were measured to be 8 meters. This measurement was

validated by comparing it with a 2024 photo investigation, which confirmed that the diameter of the bridge fender was also 8 meters.

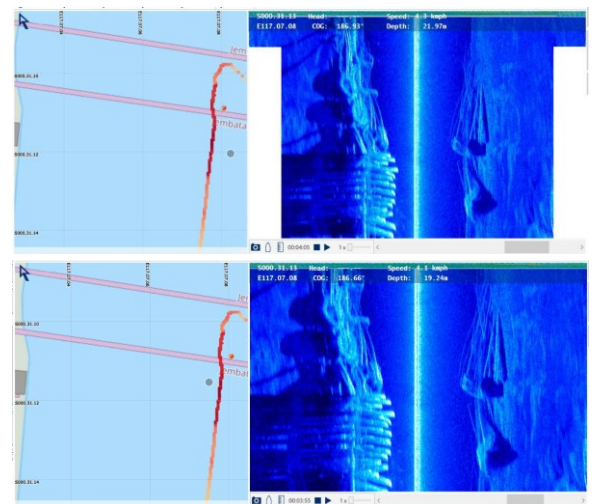
Figure 13. Dolphin Debris Position

The position of the debris object, designated as Fender Debris 1, is observed to be on the right side of Bridge Pier 3, located at a distance of approximately 20 to 22 meters.

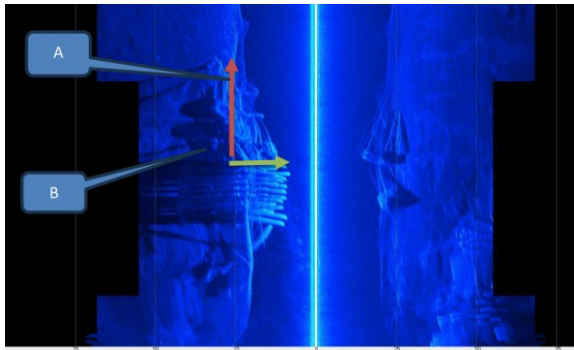
Figure 14. Dimensions of the dolphin debris in front of Pier 3

The debris field, designated as Fender Debris 1, is positioned upstream from Bridge Pier 3, located approximately 21 to 22 meters away.

Figure 14 allows for the identification and measurement of the length and width dimensions of this debris located on the upstream side of Pier 3:

- A (Length) = 42.6 Meters
- B (Width) = 14.5 Meters

Using these identified length and width data, the estimated area occupied by the debris is approximately 617.7 m<sup>2</sup>. This area is primarily dominated by numerous pieces of fender debris, including components identified as the fender head and other structural debris from the fender unit.

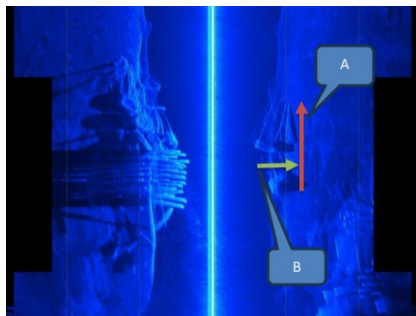
Figure 15. Dimensions of Dolphin Debris Next to Pier 3

Based on Figure 15, the dimensions of the fender debris located on the side of Bridge Pier 3 can be identified as follows:

A (Length) = 51.5 Meters

B (Width) = 14 Meters

Using these identified length and width measurements, the estimated area occupied by this debris is approximately 721 m<sup>2</sup>. The visible objects within this area consist of numerous debris pieces with elongated dimensions, clearly showing forms such as cylindrical piles attached to the main fender head.

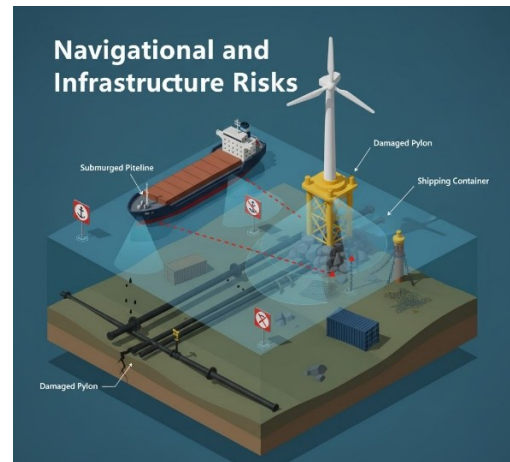
Figure 16. Navigational and Infrastructure Risks

Debris fields pose hazards:

- Navigation: Reduced channel depth (4.2–4.8 m vs. design 5.0 m) risks grounding (Chen, 2018).
- Bridge Integrity: Debris increases scour potential during floods (Fezzani et al., 2018).

Relocation of navigation aids was recommended to 00°50'16.29" S, 117°18'24.59" E, away from debris (Efendi, 2025).
