## **Integrated Geoelectric-Geotechnical Characterization For Landslide Mitigation In East Kalimantan, Indonesia**

A significant landslide affecting Syarifuddin Yoes Road in the Kutai Basin, East Kalimantan, was triggered by elevated pore water pressure from leaking PDAM water infrastructure and inadequate surface drainage. This investigation integrated two-dimensional (2D) geoelectric resistivity surveys (Schlumberger configuration), Standard Penetration Tests (SPT), and visual inspection from 4-meter-deep test pits to characterize the 60-meter rotational failure mechanism. Visual analysis revealed a continuous soil flow. A robust inverse correlation was established: low-resistivity anomalies (1–50 Ohm-m) directly corresponded with low SPT N-values (2–8 blows/30 cm) and weak saturated clays. Borehole data detected groundwater at 4 meters, aligning with low-resistivity anomalies at 4.5 meters. This multi-method approach successfully identified the primary weak slip surface at a depth of 5 to 8 meters. The geoelectric method is recommended as an efficient, cost-effective initial benchmark for spatial subsurface characterization before costly intrusive boring. These integrated subsu

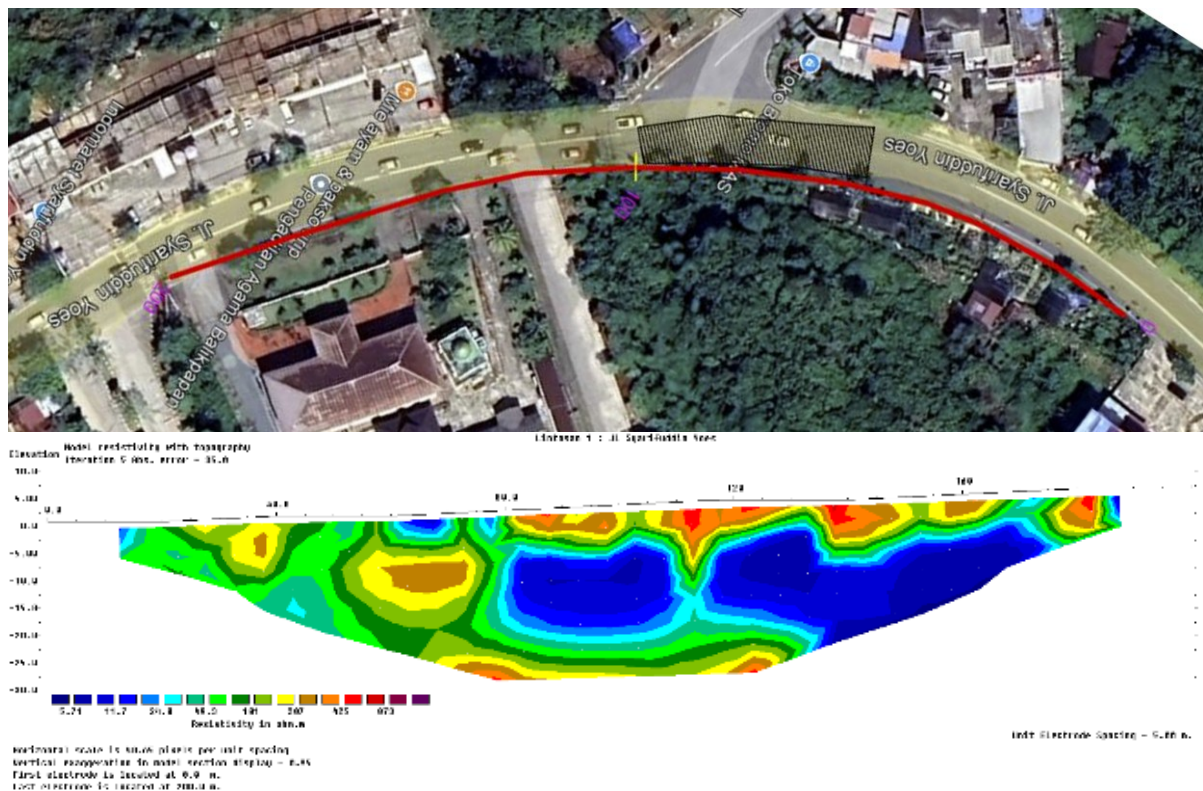
**Figure 5.** Geoelectric Data Results for Syarifudin Yoes Street, Station 3+634

The 2D resistivity inversion model along the landslide profile successfully mapped three

distinct subsurface zones. The shallowest layer, extending from the surface to a depth of approximately 2 to 4 meters, exhibited moderate resistivity values ranging from 100 to 300 Ohm-m. Based on the reference table for common rocks and minerals, these values correspond to moderately dry topsoil and loose sand. The second layer, located between depths of 4 and 9 meters, displayed very low resistivity values, predominantly between 1 and 50 Ohm-m. This zone laterally underlies the failed road section and dips toward the toe. Such low resistivity is a classic indicator of water-saturated, high-plasticity clay or weathered shale. The third layer, underlying the low-resistivity zone at depths greater than 9 meters, showed a significant

increase in resistivity (500–2000 Ohm-m), interpreted as competent, unweathered sandstone and greenstone bedrock. The geometry of the low-resistivity second layer forms a concave shape, geometrically consistent with a rotational slip surface shown in figure 5 (Al-Heety et al., 2020; Anderson & Brown, 2019; Baker et al., 2018; Chambers et al., 2014; Dahlin & Zhou, 2004; Fikos et al., 2012; Godio et al., 2019; Hunt, 2005; Ismail et al., 2021; Jain & Singh, 2020; Kearey et al., 2002; Loke & Barker, 1996; Milsom, 2003; Naudet et al., 2008; Osazuwa & Chinedu, 2019; Palacky, 1987; Perrone et al., 2014; Reynolds, 2011; Safani et al., 2005; Sumanovac & Weisser, 2001; Ward, 1990).

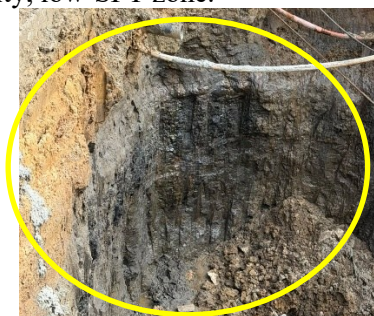
**Figure 8.** The condition of the soil is saturated with water, according to geoelectric results there are pockets of water at that depth.

Visual analysis presented in Figure 8 identifies a continuous soil flow mechanism, a finding further corroborated by intrusive data. Specifically, a proximate SPT boring log encountered a stable groundwater table at 4 meters, which aligns precisely with high-resolution geoelectric profiles showing low-resistivity anomalies at 4.5 meters, indicative of saturated conditions and discrete water pockets. Based on this robust correlation, the geoelectric method is recommended as an effective, efficient, and cost-comparative benchmark for initial subsurface soil characterization, providing critical spatial data before more costly and time-consuming investigative methods.

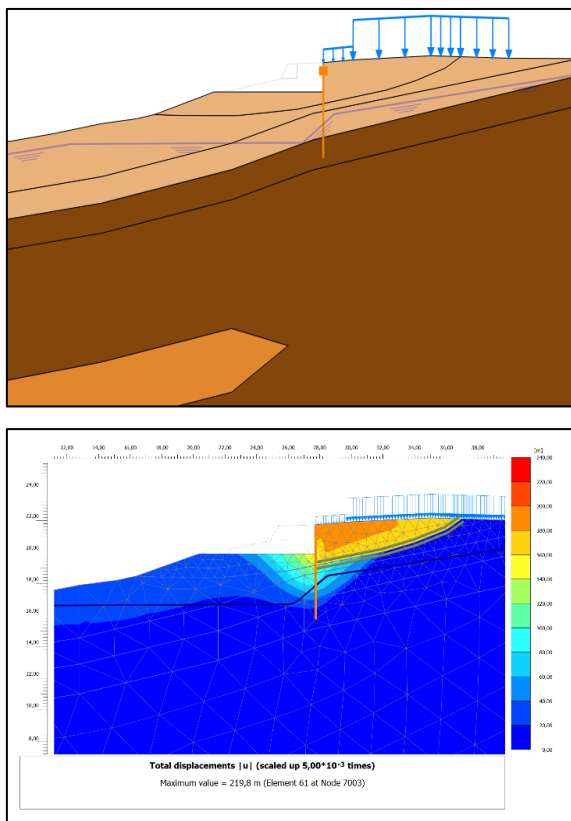
Figure 10. Geotechnical simulation analysis

Two alternatives were evaluated: Alternative 1 involves Deep Mixing Piles (DPT) combined with Bored Piles (D600), while Alternative 2 proposes a Contiguous Bored Pile (D600 mm) wall. The contiguous bored pile is highly recommended as it penetrates through the low-resistivity weak zone (4- 9 m) and sockets into the high-resistivity bedrock (> 9 m), providing sufficient structural rigidity to resist the lateral thrust of the saturated clay mass. Furthermore, the PDAM pipe must be repaired, and a comprehensive surface and subsurface drainage system must be installed to lower the pore water pressure, effectively increasing the resistivity and shear strength of the soil over time, as shown in Figure 10.
