## Investigation of the Collapsed Dolphin Structure of the Mahakam Bridge Using Bathymetry and Side-Scan Sonar After Collision

Aco Wahyudi Efendi <sup>1\*</sup>

### **ABSTRACT**

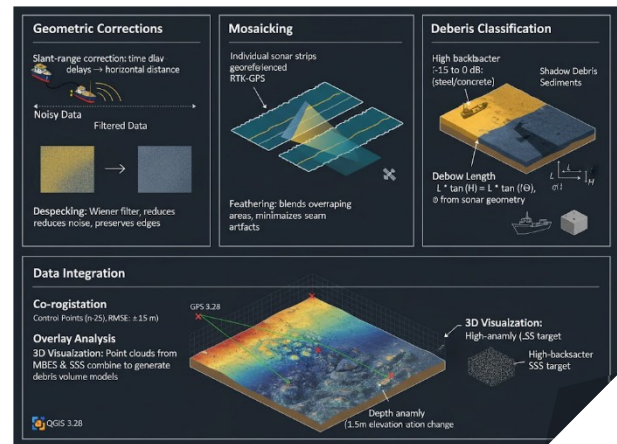
Figure 8. Data Processing

Based on figure 8 results, the condition of the riverbed reveals several identifiable objects within the Scan Window.

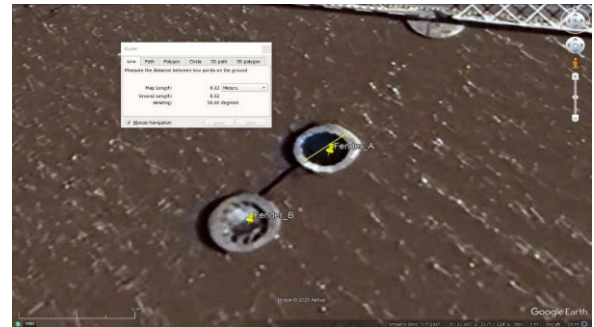
Figure 12. Layout dolphin

An object is interpreted as fender debris due to its circular shape. This particular circular section is similar in form to the original bridge fender. The visible dimensions of the fender debris object, as outlined in the black circle (in the image results), were measured to be 8 meters. This measurement was

validated by comparing it with a 2024 photo investigation, which confirmed that the diameter of the bridge fender was also 8 meters.

The position of the debris object, designated as Fender Debris 1, is observed to be on the right side of Bridge Pier 3, located at a distance of approximately 20 to 22 meters.

Relocation of navigation aids was recommended to 00°50'16.29" S, 117°18'24.59" E, away from debris (Efendi, 2025).
